A 0374 + BMWF650GS/800

Inspection completed

Frame No. WB10218089ZT36473		Color	RED	Number Plate	
Engine Model 802EA 08548546		Displacement	800cc	Starting Bid	
Meter	70,149K	Year	H21	BID	<input type="button" value="Sold"/>
Meter of Public Vehicle inspection	67,500K	Registration	R 6/ 4		
Meter history of past		Genuine Parts	No Part

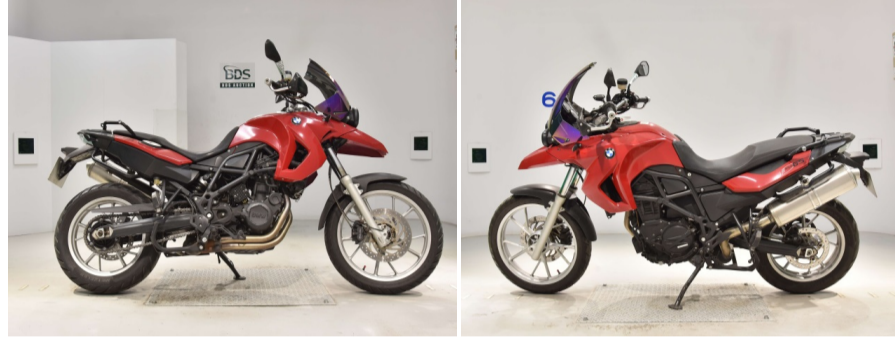
Rank	Engine	Front	Exterior	Rear	Electronic Safety Parts	Frame
4	3	4	3	4	5	4

Engine	EngineNoiseLv3 Rust Puffed smoke	Tube outer	OuterFlawLv3 Seal failure
Crankcase cover	CoverFlaw	Tube inner	InnerRust
Oil leak		Stem steering	
Radiator	RadiatorRust	Steering handle bar	HandleRust,End-partShaved,CoverPartial paintLv3failure FlawLv3,PostNot Genuine product
Carburetor		Front Wheel	WheelFlawLv3 Rust
Clutch		Front Brake	BreakDiskRequired replacement
Starting motor		Front Tire	TireDecreased or Crack

Upper cowl	UpperFlawLv3	Rear shock	ShockRust
Center cowl	CenterFlaw	Swing arm	SwingarmFlaw Rust
Under cowl		Chain	ChainRust
Side cowl	SideFlaw	Sprocket	
Tank fuel	TankFlawLv3	Rear Wheel	WheelFlawLv3 Rust
Seat		Rear Brake	BreakRust
Tail cowl	TailFlawLv3	Rear Tire	
Front fender	Front-fenderFlaw		
Rear fender			
Screen	ScreenFlaw Not Genuine product

Key	Key1	Mainframe	Main-frameFlaw RustLv3
Meter	LensCrackLv1	Downtube	
Turn-signal	Turn-signalCrack ShortageLv1	Stopper	
Headlamp		Seatrail	SeatrailFlaw
Battery		Step	StepFlaw Rust BendLv1
Horn		Stand	StandFlaw Rust Shaved Treatment
Back-lamp			
Mirror	MirrorFlaw		
Silencer	SilencerFlaw		
Exhaustpipe	Exhaust-pipeRust
