D 7703 Y MT-07

Inspection completed

Frame No. RM07J-000027		Color	WHITE	Number Plate	
Engine Model M403E-000028		Displacement	700cc	Starting Bid	
Meter	41,775K	Year	H26	BID	<input type="button" value="Sold"/>
Meter of Public Vehicle inspection	40,400K	Registration	R 6/ 9		
Meter history of past		Genuine Parts	No Part

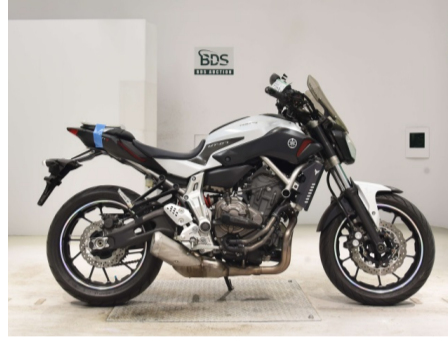
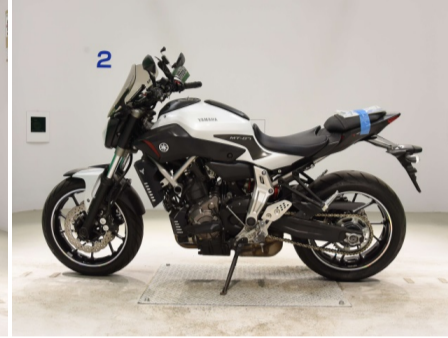
各所变色。

Rank	Engine	Front	Exterior	Rear	Electronic Safety Parts	Frame
4	4	4	5	4	4	4

Engine	EngineRust,UnderFlawLv3 Partial paint	Tube outer	OuterFlawLv3 Partial paint Shaved Oil leakLv1
Crankcase cover	CoverFlawLv3 Rust	Tube inner	
Oil leak		Stem steering	StemRust
Radiator	RadiatorRustLv3,FinDent,HoseFlaw Partial paint	Steering handle bar	End-partNot Genuine product,LeverNot Genuine product,GripNot Genuine product
Carburetor	CabRust	Front Wheel	WheelFlaw Rust
Clutch		Front Brake	BreakRust Diskworn-down
Starting motor		Front Tire	TireReduceRequired replacement

Upper cowl		Rear shock	ShockRustLv3
Center cowl	CenterFlawLv3 Shaved	Swing arm	SwingarmFlaw Rust
Under cowl		Chain	ChainRust
Side cowl		Sprocket	
Tank fuel	TankFlaw,PatInstalled	Rear Wheel	WheelFlawLv3 Rust
Seat		Rear Brake	BreakRust
Tail cowl	TailFlaw	Rear Tire	TireReduce
Front fender	Front-fenderFlaw		
Rear fender	Rear-fenderFlaw		
Screen	ScreenFlaw

Key	Key3	Mainframe	Main-frameFlaw Rust
Meter		Downtube	
Turn-signal	Turn-signalFlaw Not Genuine product	Stopper	
Headlamp	HeadlampFlaw,InnerNot Genuine product	Seatrail	SeatrailRust
Battery		Step	StepFlawLv3 Bend Rust
Horn		Stand	StandRustLv3
Back-lamp	Back-lampFlaw		
Mirror	MirrorFlaw		
Silencer	SilencerRust,CoverFlawLv3 Dent		
Exhaustpipe	Exhaust-pipeRustLv3
